HEMA AMASRA HARDCOAL PROJECT BARTIN, TURKEY

HEALTH AND SAFETY ASSESSMENT and SOCIAL – LABOR AUDIT FOLLOW-UP

HATTAT Enerji Maden Ticaret A.Ş.
HA1144
DRAFT REPORT
21.03.2015, Rev.01

Task B2a Social-Labour Audit of Chinese Contractor

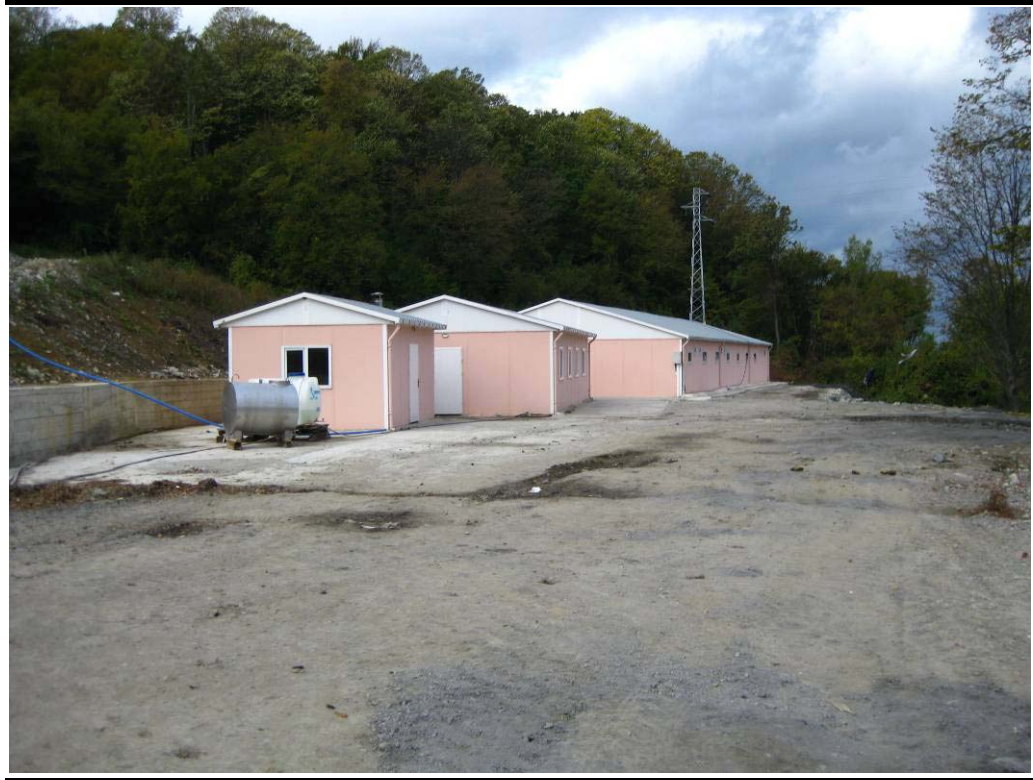
Photo 1 *Workers' accommodation at Shaft # 1.*

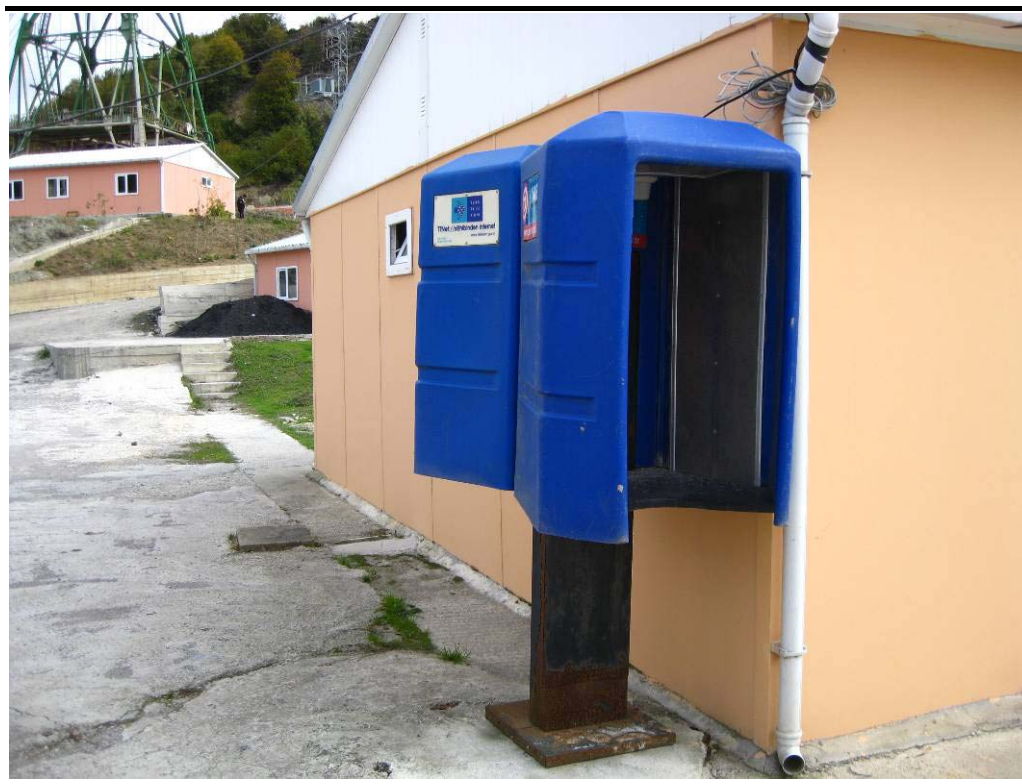
Photo 3 Telephone booth for Chinese workers at Shaft # 2.

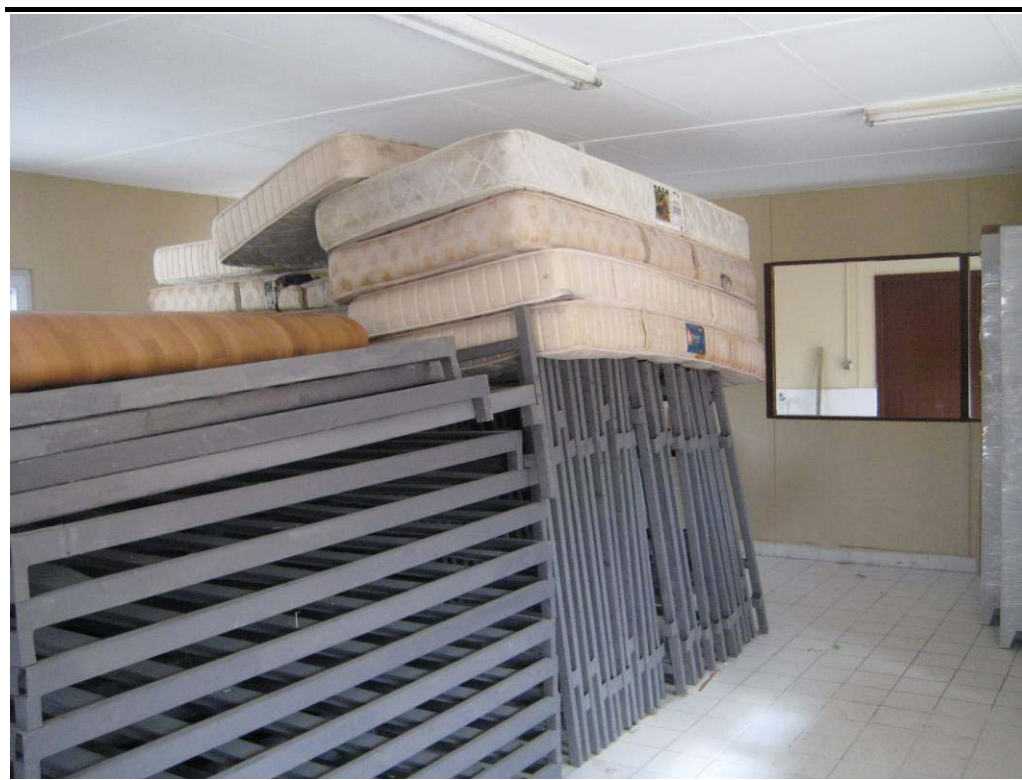
Photo 4 Bunk beds and mattresses ready for Chinese workers due to arrive on-site at Shaft # 2.

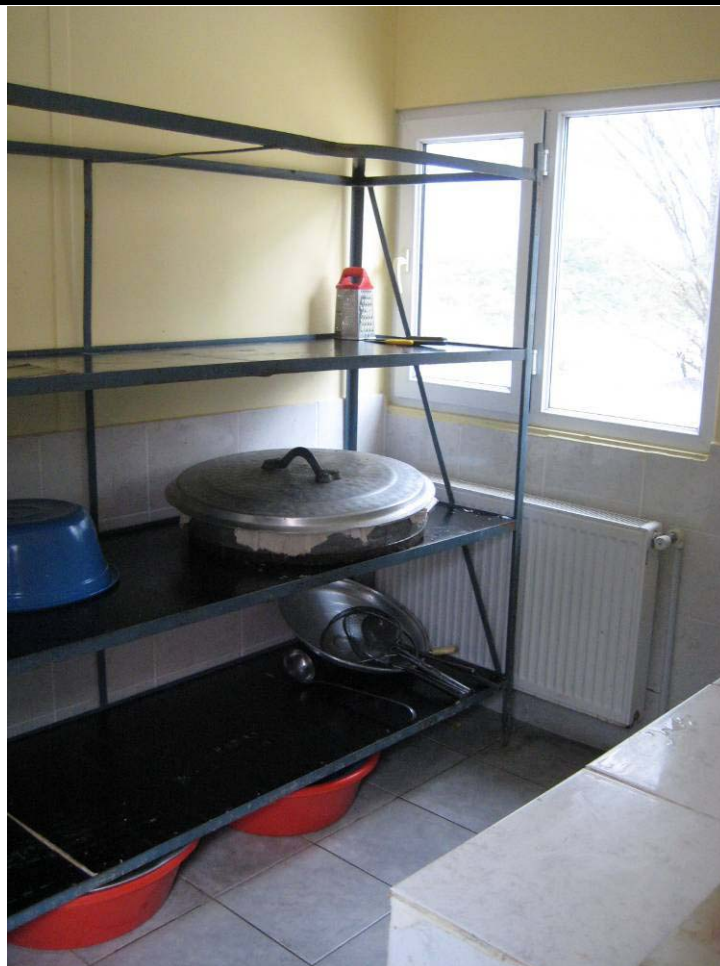
Photo 11 Kitchen used by the Chinese workers at Shaft # 1 with food stored on the floor.

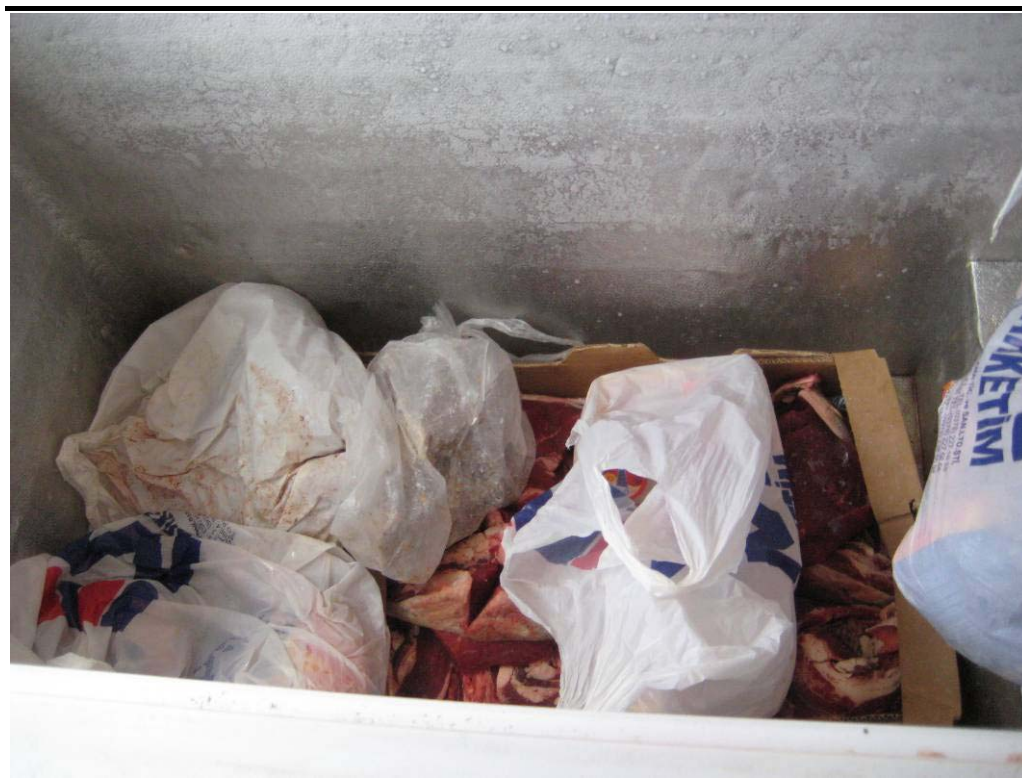
Photo 12 Freezer in the kitchen used by the Chinese workers at Shaft # 1.

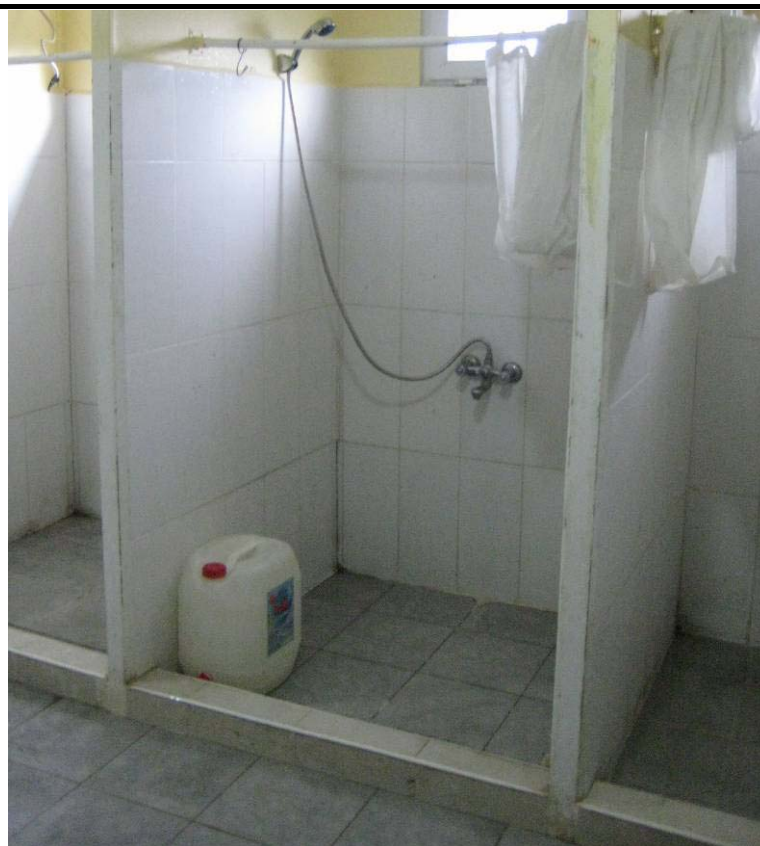
Photo 19 Showers in Chinese workers' accommodation at Shaft # 1.

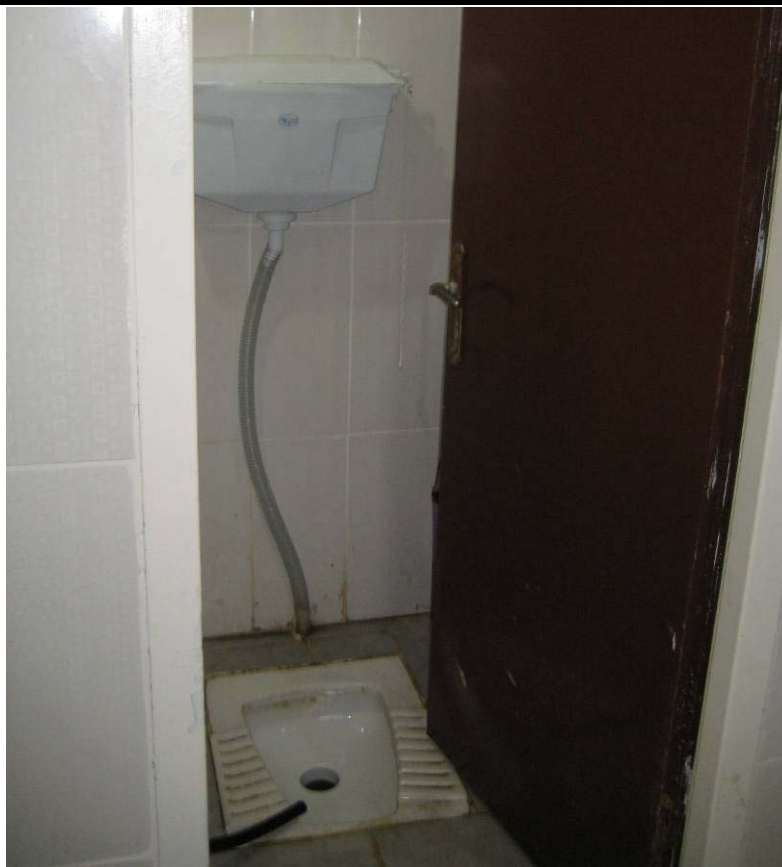
Photo 20 Toilet in Chinese workers' accommodation at Shaft # 1.

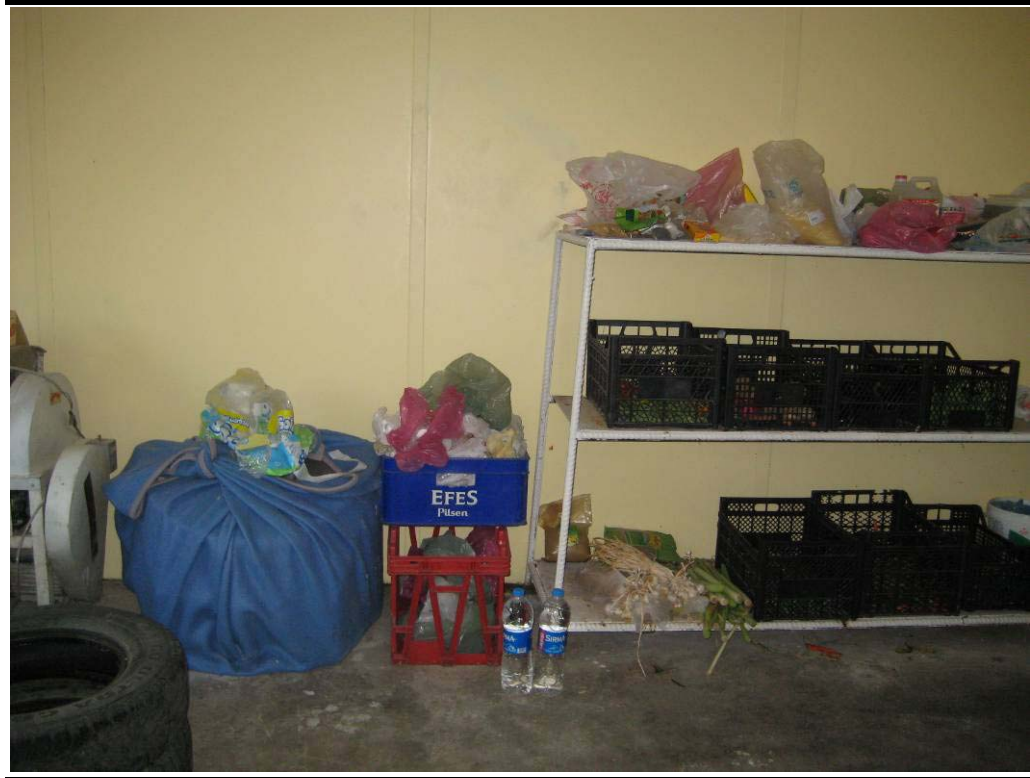
Photo 26 Food storage for the Chinese workers at Shaft # 3.

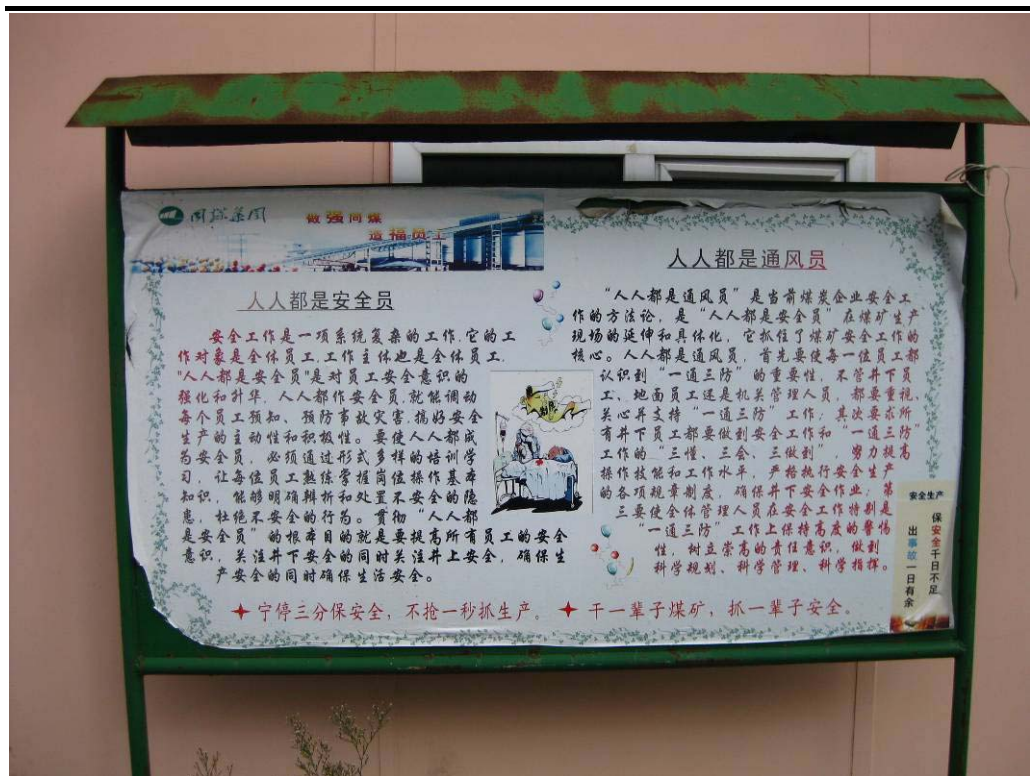
Photo 27 Safety poster for the Chinese workers, outside of workers' accommodation at Shaft # 3.
