3.5.6. HEMA2 Havalandırma Kuyusu ile Yakınındaki Yeraltı Suyu İşletme Kuyusunun Kavşak Suyu, Selen Suyu ve Kaman Köyü İçme Suyu Kuyusu ile Etkileşiminin İrdelenmesi

The worksite, being within the borders of the city of Bartın, between Bartın and Amasra accommodation units, including the coastal area between Amasra and Tekke Cape, encompasses a 5x10 km area towards south. The worksite comprises the town of Amasra, Tarlaağzı, Gömü, Kazpınarı, Bostanlar and Kaman Bay (Figure 1).

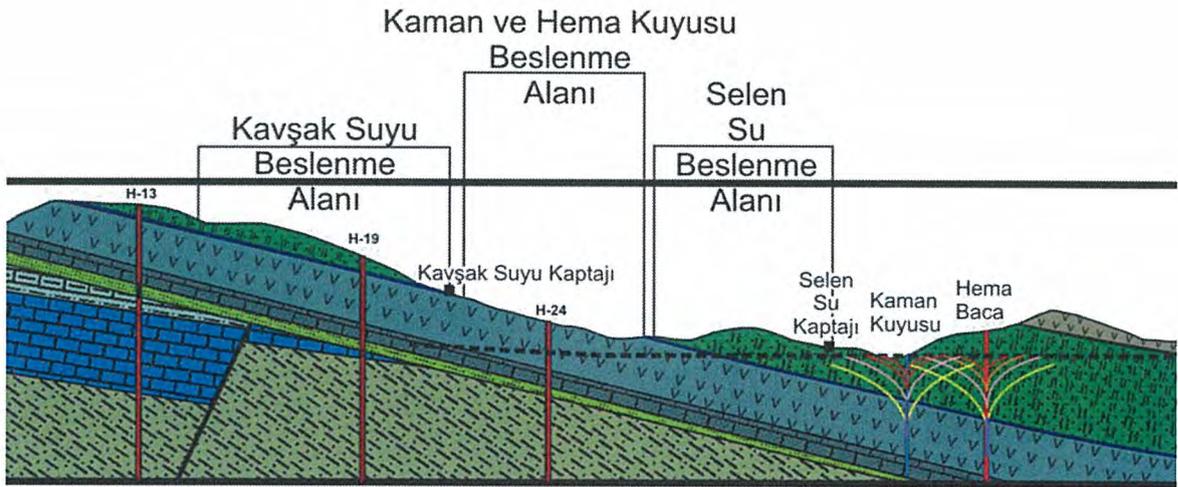
Şekil 22. Kavşak Suyu, Selen Suyu, HEMA2, HSK1 ve 13 no.lu Kaman İçme Suyu Kuyusu arasındaki jeolojik-hidrojeolojik ilişki ve beslenme alanları (lejant, ölçek vb için bkz EK1)

(Üst Kretase – Santoniyen yaşlı Andezit-Aglomera) su almaktadırlar (Şekil 22). Üzerinde yer alan geçirimsiz nitelikteki marn nedeniyle akifer basınçlı karakterdedir. Hidrolik açıdan birbiri ile bağlantılı olan bu kuyular, kimyasal açıdan da aynı karakterdedirler. Dolayısıyla bu kuyulardan herhangi birinden yapılacak su çekimi diğer kuyuları etkileyebilir. Ancak, her kuyunun etrafında su çekim miktarı [Q], akiferin hidrolik özellikleri (transmissibilite[T], depolama katsayısı[S]) ve zamanın [t] fonksiyonu olarak bir düşüm konisi oluşur. Bu değerlerin bilinmesi durumunda çekim yapan herhangi bir kuyunun düşüm konisinin yarıçapının diğer bir kuyunun düşüm konisine ulaşip onu etkileyip etkilemeyeceği, etkileyecekse ne zaman ne kadar etkileyeceği hesaplanabilir. Akiferin hidrolik katsayılarının, pompaj kuyusu yanına açılacak bir gözlem kuyusu ile ölçüm yapılarak hesaplanması gerekir. Bu türde bir test yapılmadan yukarıdaki sorulara net yanıt vermek mümkün değildir.

Kavşak Suyu'nun akiferi Üst Kretase- Kampaniyen yaşlı Tüf, Kumtaşı, Silttaşı ve Kireçtaşı'ndan oluşan birimdir (Şekil 22). Alttaki andezit akiferi ile üstündeki tüf akiferi aradaki geçirimsiz marn ile birbirinden ayrılmaktadır. Bu birim içerisinde yağış suyu bu birimin çatlakları arasında hareket etmektedir. Çok sığ dolaşımı olan yeraltı suyu, akifer içerisinde hidrojeolojik açıdan çok kısa bir süre (bir kaç ay) akifer içerisinde hareket etmektedir. Yağışlardan hızlı bir şekilde etkilenmekte ve yağışlı zamanlarda bulunmaktadır.

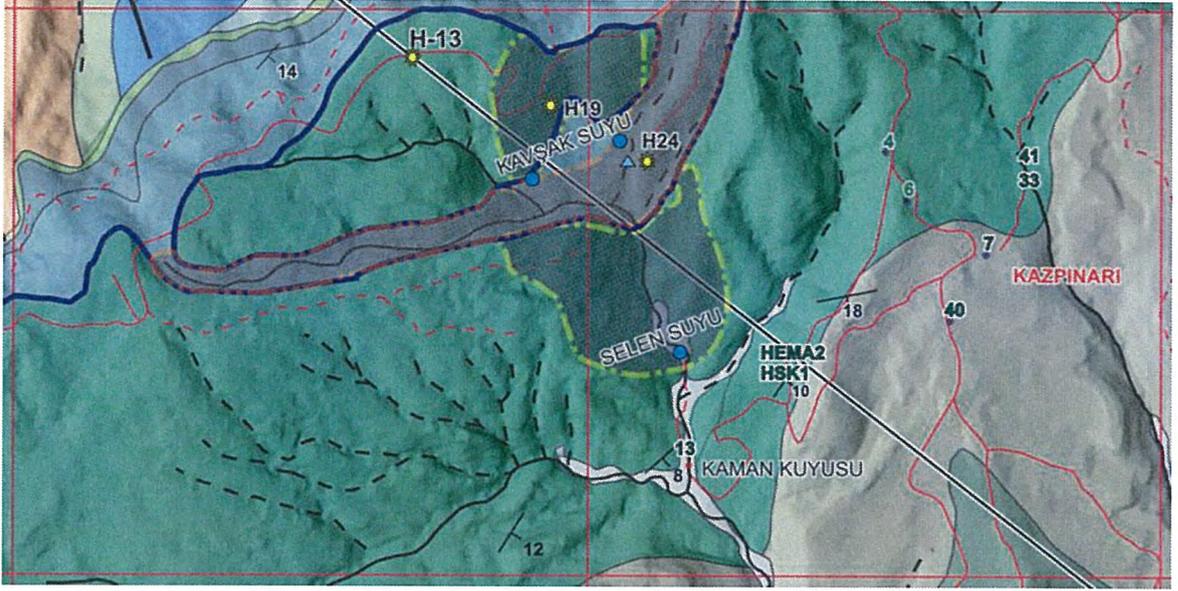
Şekil 23. Kavşak Suyu, Selen Suyu ve 13 no.lu Kaman İçme Suyu Kuyusu beslenme alanlarını gösteren harita (lejant, ölçek vb için bkz EK1)

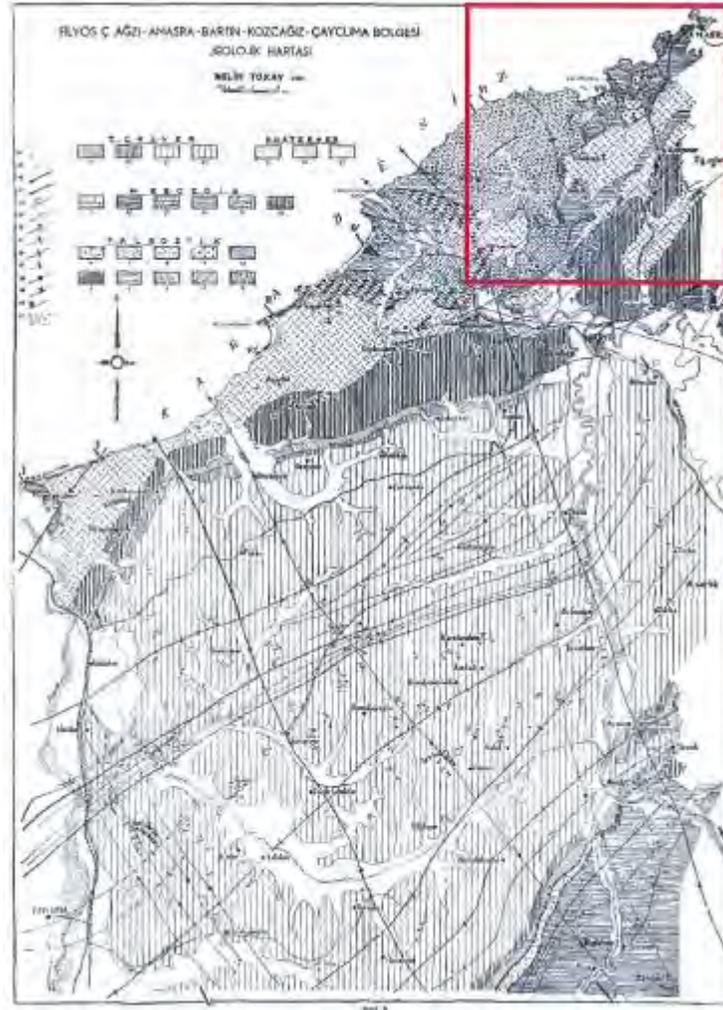
Figure 2: The Geological Map of the Region (Tokay, 1954/55) (The worksite is identified with the red borders.)

In the area between Bartın and Amasra, there are Paleozoic (Lower Devonian-Permian), Mesozoic (Cretaceous), Tertiary (Paleocene-Lutetian) and Quaternary formations. Paleozoic is observed in the north, Cretaceous is in the north and southeast, Tertiary is in the southwest on the surface (Figure 2).

Upper Cretaceous-aged volcanic rocks contain andesite, basalt, agglomerate and tuff (Figure 2 and 3). Within this unit exist marl, limestone and tuffite which contain volcanic materials. On the Amasra-Bartın route, near Asker water area, andesite, agglomerate and tuff rest on sedimentary rocks. Sediments here are observed as sandstone, sandy marl and marl which contain volcanic materials. In the east and northwest Meşelik Hill especially agglomerate and tuff predominate. On the other hand, in the Kavşak water area, andesites predominate (Coniacian, Santonian, Kampanian; Dinlence, İkse and Kazpınar formations). Towards southwest, these andesites become thin-layered marls with tuff and volcanic elements (Tokay, 1954/55).

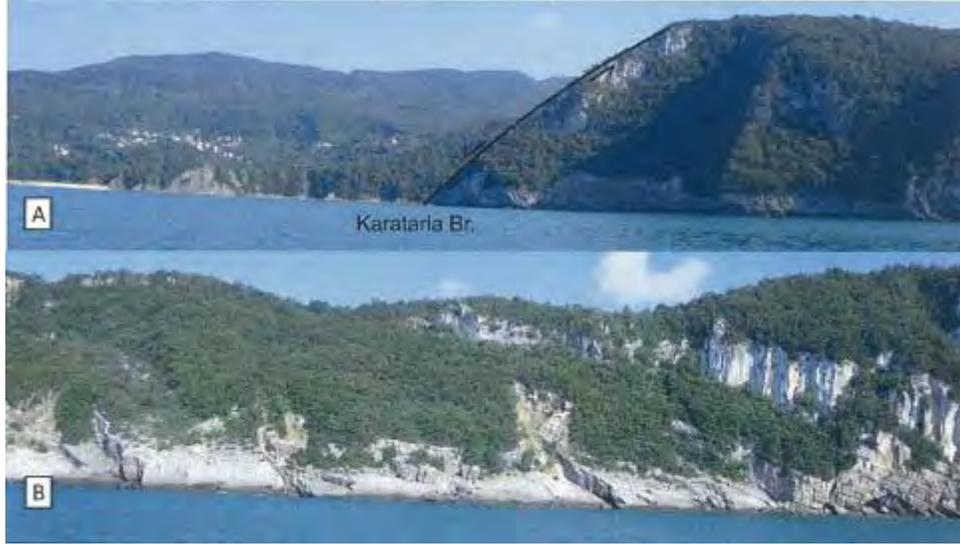
Figure 3 A: The normal fault that forms the Karatarla Cape (facing south) B: The north sloping limestone layers between the Poyraz Cape and Delikli Cape

The thickness of the Visean-aged limestone layers range from 30-40 cm to 7-12 m. Limestones are fossiliferous and sporadically contain chert nodules and lenses inside the layers. In the east of the worksite, in Kirazlıtarla Bay, between the Visean-aged limestones Namurian-aged silt and mudstones is limited by a normal fault (Figure 3A and 3B, Attachment 1 Geology Map).

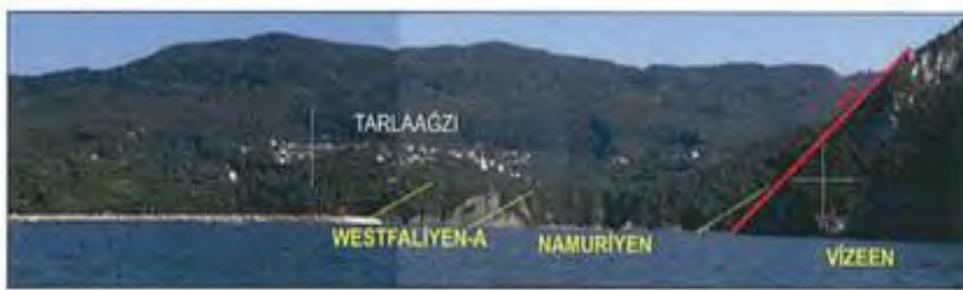
Figure 4: The position of the carboniferous stack to the east of Tarlağzı village

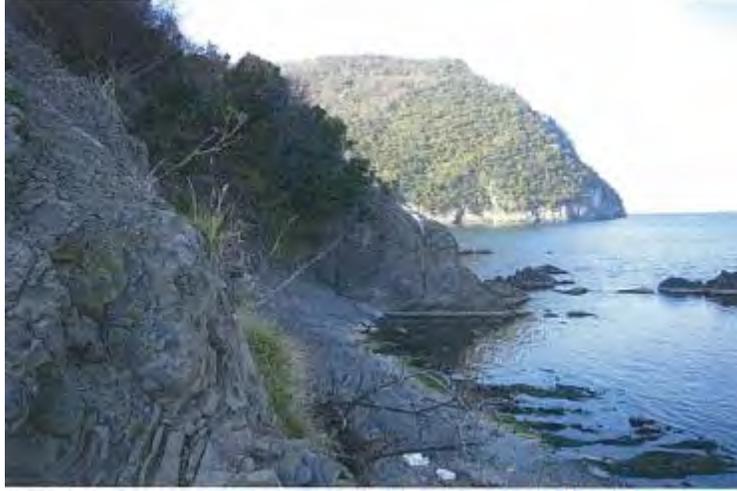
Figure 5: The look of Westfalian-A series from the west of the Kirazlıtarla port

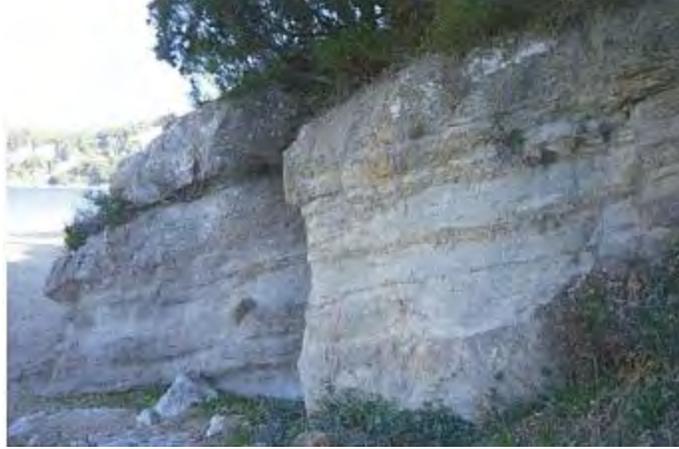
Figure 6: Conglomerate intercalated sandstones that belong to the Westfalian series on the east of the Kirazlıtarla port

The characteristic of the Westfalan B-C-D series is being carbonous. The dominating units of the stack which is about 400 m thick are the middle coarse sandstones, thin middle layered dark gray-colored siltstones and sandstones deposited in the context of a river. In the sections of the stack in the Tarlağzı village that contains conglomerate lenses, the predominating units are the pebbly sandstone levels. In the upper sections small scale drift structures, in the sections that contain coal levels schiefer-ton levels, conglomeratic sandstone pebble stone intercalations along the coast in the east of the port give outcrop (Figure 6).

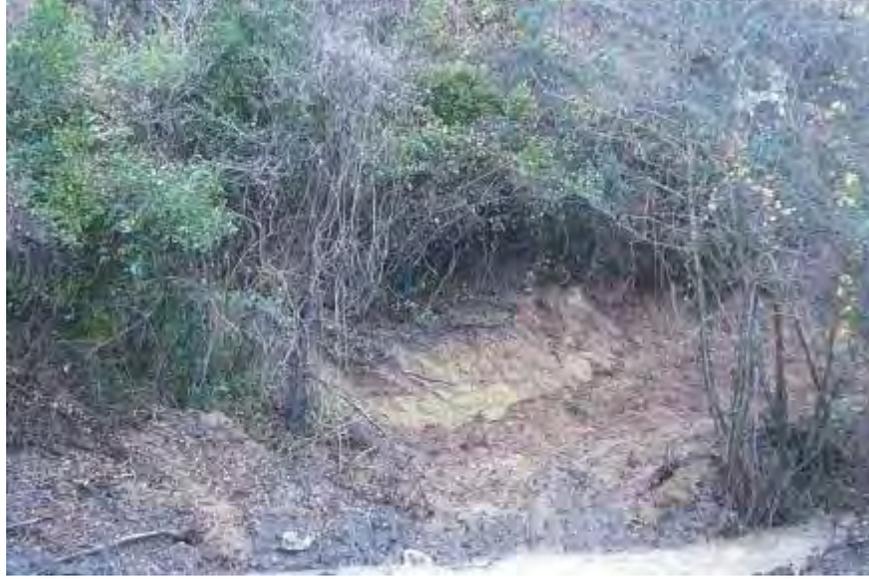
Figure 7: Multicolored sandstones that belong to the Permian series in the stream bed located to the west of Kirazlıtarla port

At the worksite, the top section of the Paleozoic stack is followed by the Permian-aged multicolored sandstone shale stack (Şekil 7). In the stream bed from the east of Kirazlıtarla Bay to the Gümü village, stack can be observed. In the sandstones with layers that have similar thickness, sedimentary structures are less. Sandstones are red, but thin-grained thick-layered shales are green and yellow-colored, middle layered.

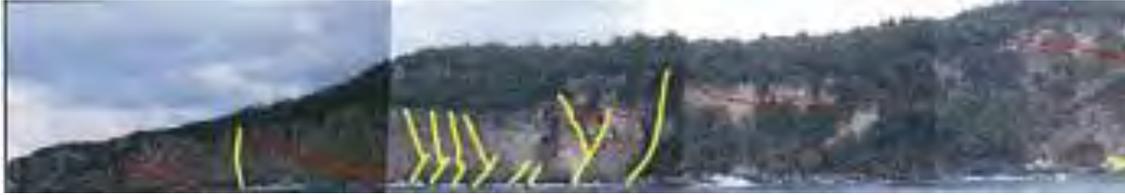
Figure 8: The look of Lower Cretaceous-aged limestones on the cape that is on the left of Tarlağzı port. (The yellow line shows the paleo-landslide contact of the Paleozoic stack with the limestones)

Mesozoic: Above the Paleozoic stack at the worksite, Cretaceous-aged two packets lie in angular discordance. There is angular discordance between the two packets. Lower Cretaceous-aged stack is considered as two different packets. These are lower series composed of marl-limestone and upper series composed of shale-sandstone and marl. Carbonated section and the lowest section of the stack that is predominated by middle-thick layered limestone start with the conglomerate that is derived from the base. Over these sections whose thickness sporadically reach a few meters come carbonated sandstones and towards the top come sparitic limestones. The area in which this series is best observed is the east coast of Kirazlıyayla Bay and the coastline located in the north of Gömü village (Figure 8).

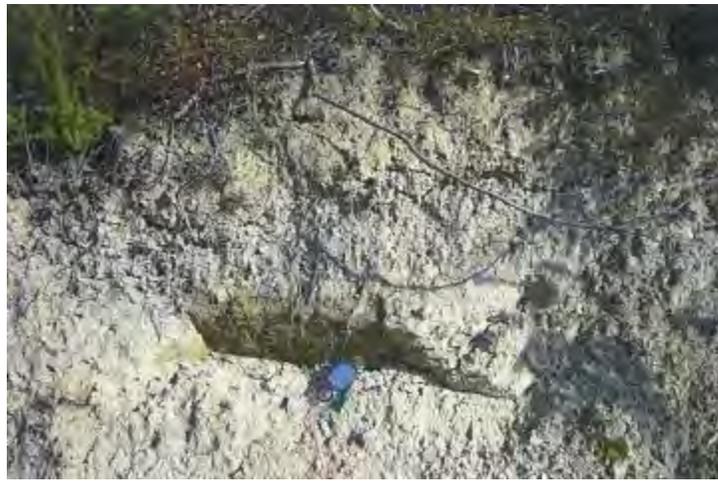
Figure 9: On the new Amasra-Bartın road Upper Cretaceous-aged carbonated sandstones

water cover both Lower Cretaceous and Paleozoic stack with angular discordance. On the new Bartın-Amasra road, the unit can be seen all along the way (Figure 9).

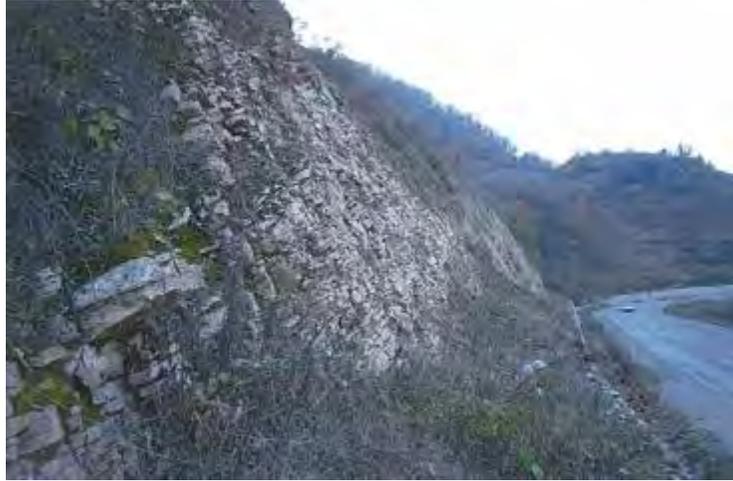
Figure 10: On the new Amasra-Bartın road Upper Cretaceous-aged pink micritic limestones

On the old Bartın-Amasra road, over the carbonated sandstones come Turonian-aged pink-colored pelagic and micritic limestones. Their layer thickness is around 10-15 cm (Figure 10). They are transitive with the Coniacian-Santonian-aged volcanic series. This transition can be seen in the roadcuts on the new Amasra-Bartın road.

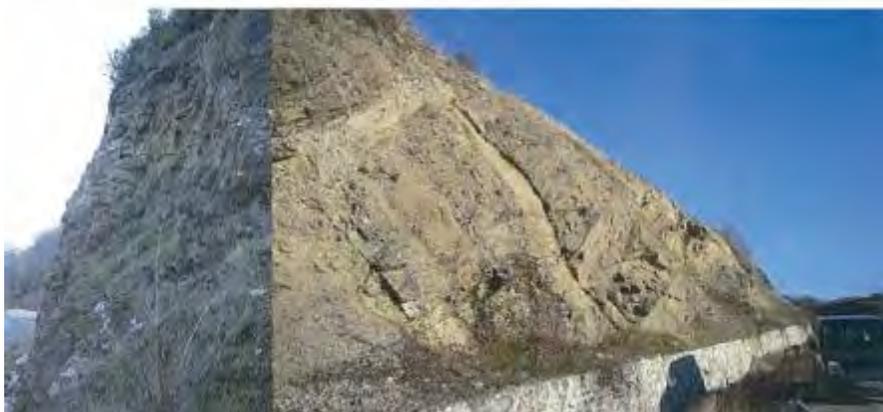
Figure 11: On the new Amasra-Bartın road, in the Upper Cretaceous-aged volcanic series, thick-layered andesites and tuffs

In a large area of the worksite, the predominating units are volcanic and volcanogenic sediments. These are products linked to volcanisms developed in the area during Late Cretaceous and have different facies. These have emerged and/or deposited in the field during the period from Coniacian to Kampanian. This series, on the Tortonian-aged limestones, is represented by two lava levels and between them thin-grained level made up of sandstone-shale sequence. It begins in the lower sections with andesitic lava. Lava, with pillow structure and product of underwater volcanisms, sporadically contain carbonated thin lenses. At the worksite, on the road from Asker water to Bartın and on the new Amasra-Bartın road, this volcanic series is present with all of its characteristics. Between andesites, agglomerates and tuffs can be observed (Figure 11).

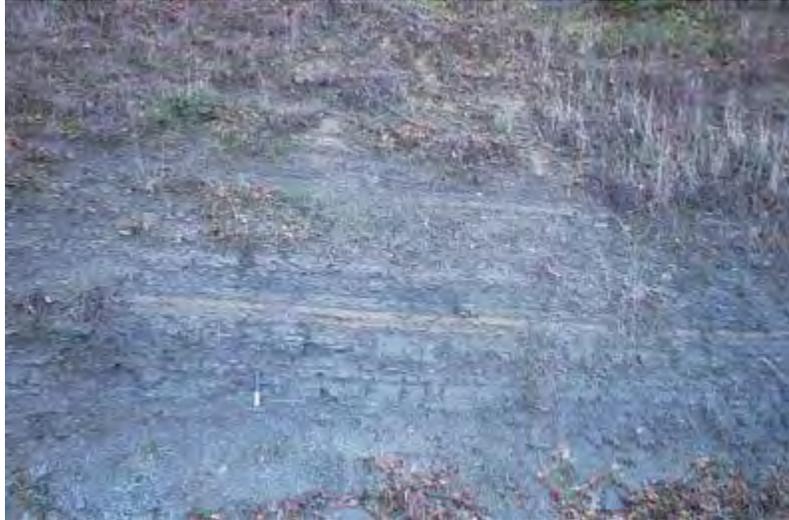
Figure 12: Sandstone-Shale sequence on the roadcuts between Kazpınarı-Hema Well

Over this volcanic series, there is a thin level of 5-10 meters that contains marl-limestone-shale. Tuff-sandstone-shale stack that rests over this level can be seen in Kazpınarı village and in all the valleys starting from the south of the mountain ridge that leads to Airforce radar. From Kazpınarı to the place in which Hema ventilation shaft is located, the upper sections of the stack have open outcrops all along the way (Figure 12).

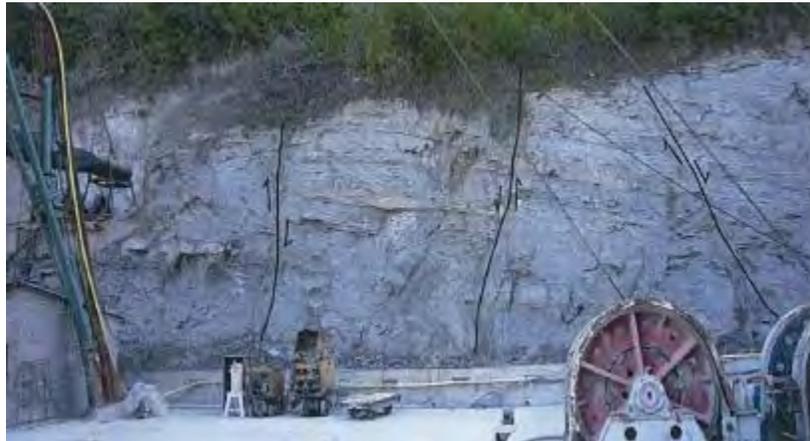
Figure 13: Normal faults in the roadcuts behind the Hema Well

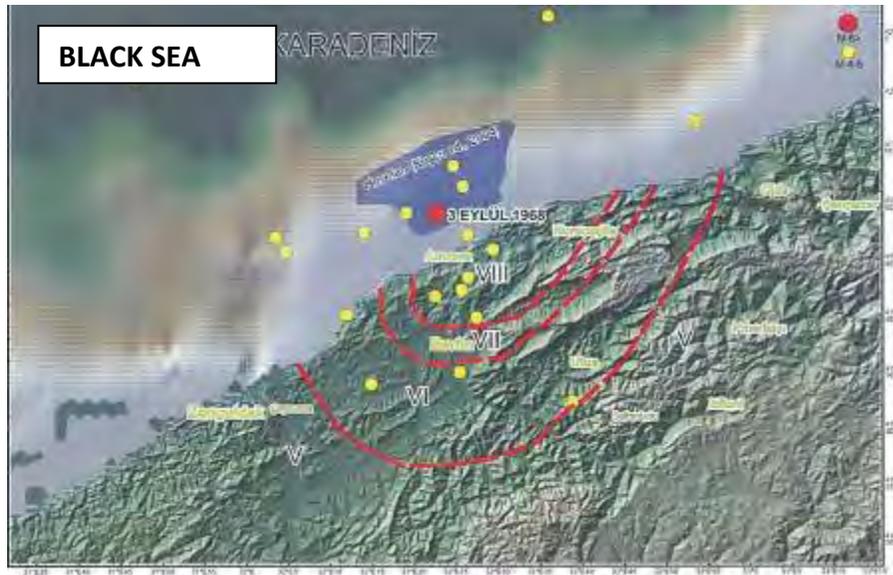
Figure 14: Seismic activity map of Bartın-Amasra and the surrounding (Data: KOERİ) Isoseismal map (Alptekin et al. 1986) Underwater landslide (Kuşçu et al. 2004)

Ketin and Abdüsselamoğlu's (1969) observations done in the area after the earthquake did not show any surface fracture. Researchers who observed that the coastline between Amasra and Çakraz raised 40-50 cm, concluded that the coast ramp represented a fault plane. In addition, researchers reported that on the Çakraz beach the sea first withdrew then came back and there was damage to a hotel on the coast. It is understood that this sea movement is a typical tsunami. Moreover, in the Amasra bay, the wave raised 1 meter and threw the boats onto the land; the first wave from the coast to the land came in for about 100 meters and the second one for about 160 meters (Wedding, 1969). Kuşçu et al. (2004), in their deep seismic work, mapped a 20 km wide landslide in the seismic sections off Amasra (Figure x). Researchers say that this landslide is Pliocene-aged. What is interesting is that, according to Bartın earthquake epicenter and isoseismal map, the area of this landslide is opposite to the most affected land area, and this shows the relation between the region's earthquake and underwater landslides.

Those who worked in the region following Bartın earthquake prepared various isoseismal maps (Albers and Kalafatçiođu, 1969; Ketin and Abdüsselamođu, 1969). As shown on the prepared maps, according to the Mercalli scale, the epicentral magnitude of the earthquake was 8 (Figure 14). All the analysis conducted for Bartın earthquake point to a strike-slip faulting with reverse faulting (McKenzie, 1972; Jackson and McKenzie, 1984). On the other hand, in the ISC bulletin, using the short period P wave first motions, Şengör et al. (1983) suggested that there was a strike-slip faulting. Alptekin et al. (1986) investigated the short and long period seismograms and suggested that Bartın earthquake was the result of reverse faulting. Analysis of reverse faulting and reverse faulting with strike-slip conducted by researchers are compatible with the rise of shore level observed in Amasra (Ketin and Abdüsselamođlu, 1969).

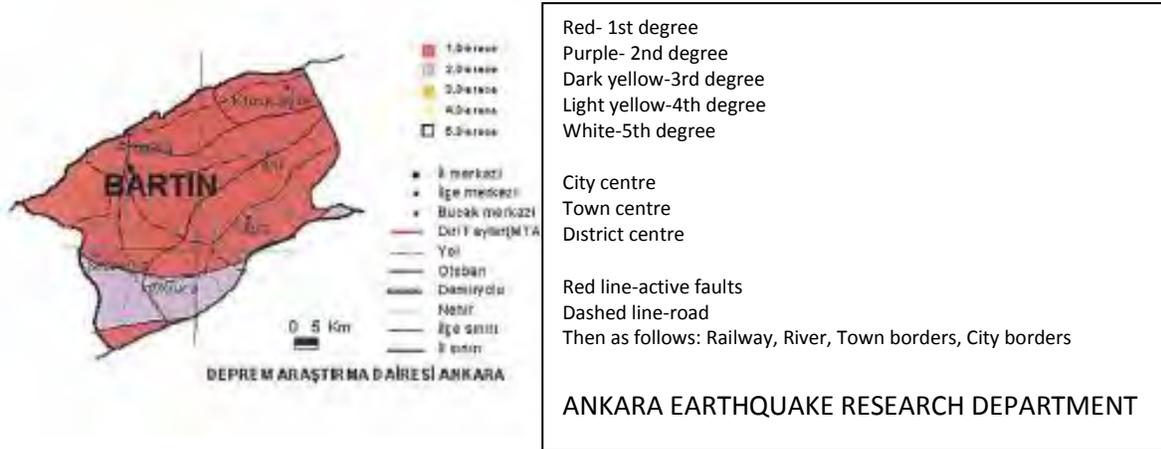
Figure 15: Earthquake risk map of the city of Bartın (<http://www.deprem.gov.tr/sarbis/depbolge/bartın.gif>)

Bartın earthquake is so far the only earthquake which shows the rise of shore level in the instrumental period. When the facts that the periods of the earthquakes happening in the thrust faults range from 400 to 20000 years and that the parallel thrusts are being mapped on the field are taken into consideration, the number of unknowns about the earthquake risk in the areas in which thrust faults are located increases. In this context, because of the 3 September 1968 earthquake, according to the risk map prepared by the earthquake research department, the city of Bartın has 1 degree earthquake risk (Figure 15).

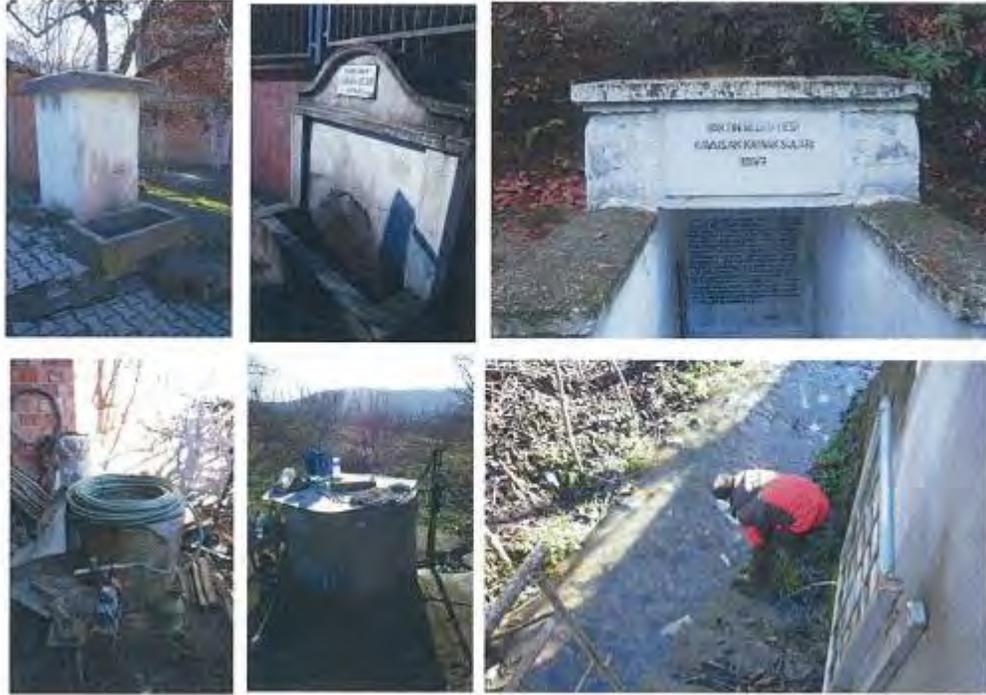
Figure 17: Look of some of the water points investigated at the worksite

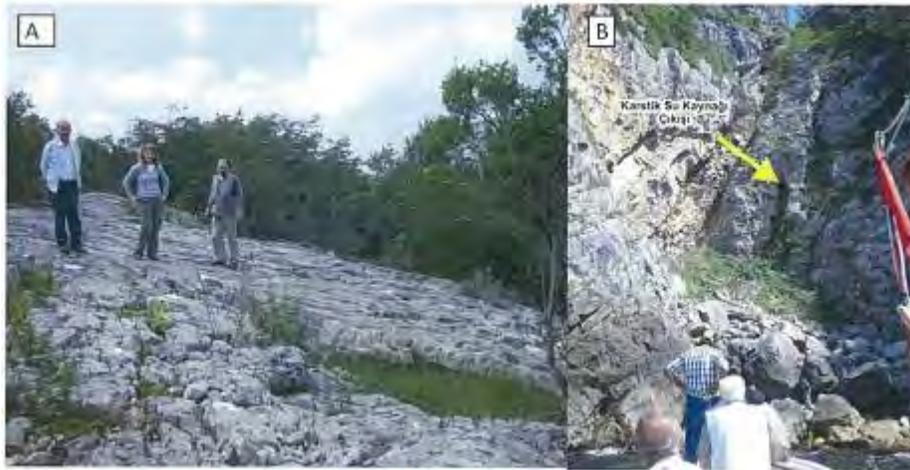
Figure 18 A: The karstic structure on the surface in the station area B: To the west of the Delikli Cape, water spring point coming out of the karstic whole

Limestones detailed in the geology section that are Paleozoic-aged, thick-layered, much convoluted and sporadically dolomitic have a fissured-carstic structure (Figure 18A), and in hydrogeological terms they are very permeable (high permeability). At the worksite and on the coast of Tekke Cape-Poyraz Cape, any water points such as lakes, rivers, springs, wells etc. are not encountered. In about 300 m west of Delikli Burun area, the existence of a water spring coming from the sea level is known to the local residents (Figure 18 B). However, during field investigation, there was no water encountered at the spring point. At the water exit point located on the spring, a weak leakage was observed. Based on this information, it is clear that limestone drains the water it gets from rainfalls quickly into the sea that has the lowest elevation, so cannot accumulate the ground water. In the area, very recently (December 2011-January 2012), ground investigations showed that there was no ground water. Even though it is a very permeable unit, it cannot store the ground water, so it does not have the aquifer characteristic.

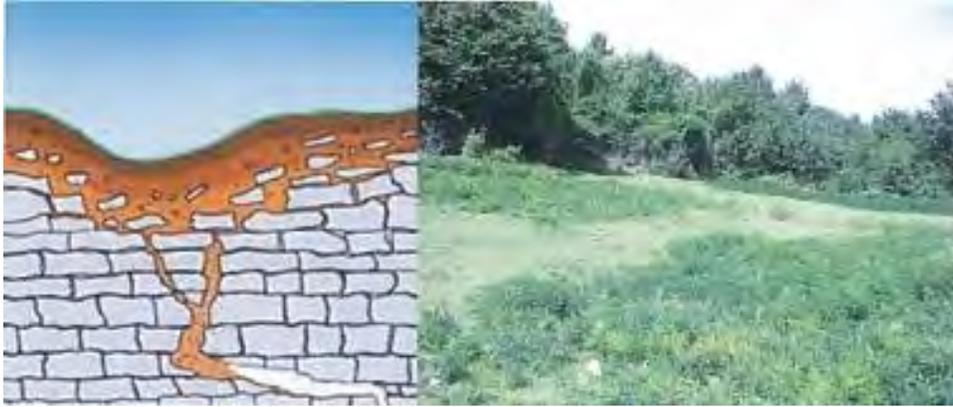
Figure 19: On the field of work, the possible structure of the dolines covered with soil and the basis of a doline in the field

However, in the field, in Sarnıç Çukuru and Sarnıçdere areas, around Karakovuz Tepe and Taşboğazı Tepe, very big and explicit sediment structures that are called doline, pothole, sinkhole etc. exist. Dolines observed during the field work are not very big on the surface and are filled with soil (Figure 19). The most important controller of the karstic characteristic of the worksite is the location of the dolomitic limestone layers. Particularly, on the seaside between Karatarla Cape and Delikli Burun, between the vertical and close-to-vertical layers, development of karstic holes is observed. Some of the caves located on the shore are sediments created by wave energy in the areas in which dissolution between layers is high (Figure 20).

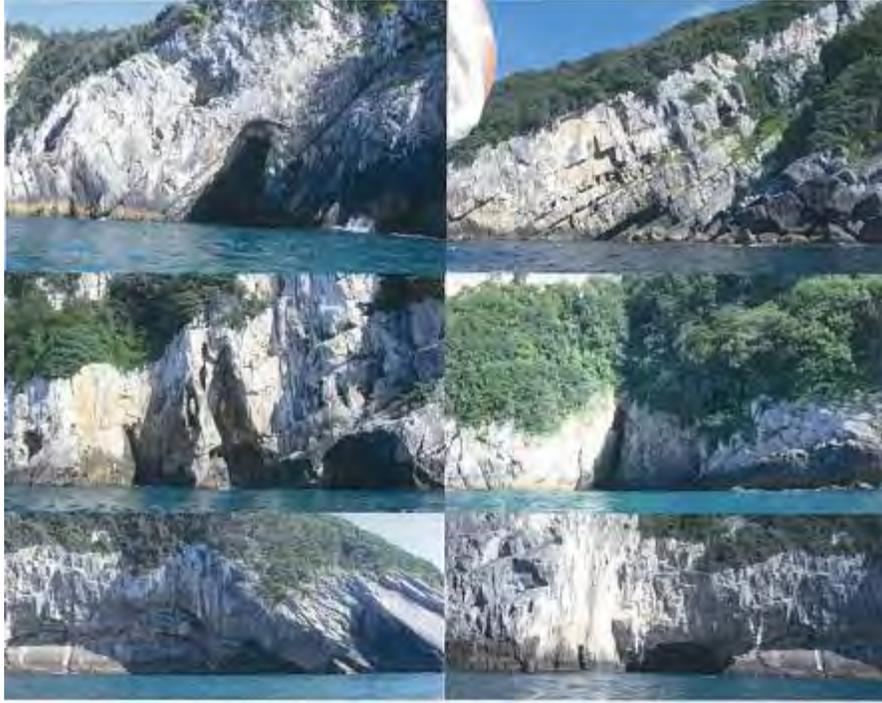
Figure 20: Wholes developed by the effect of the waves, because of the layering observed along the coast

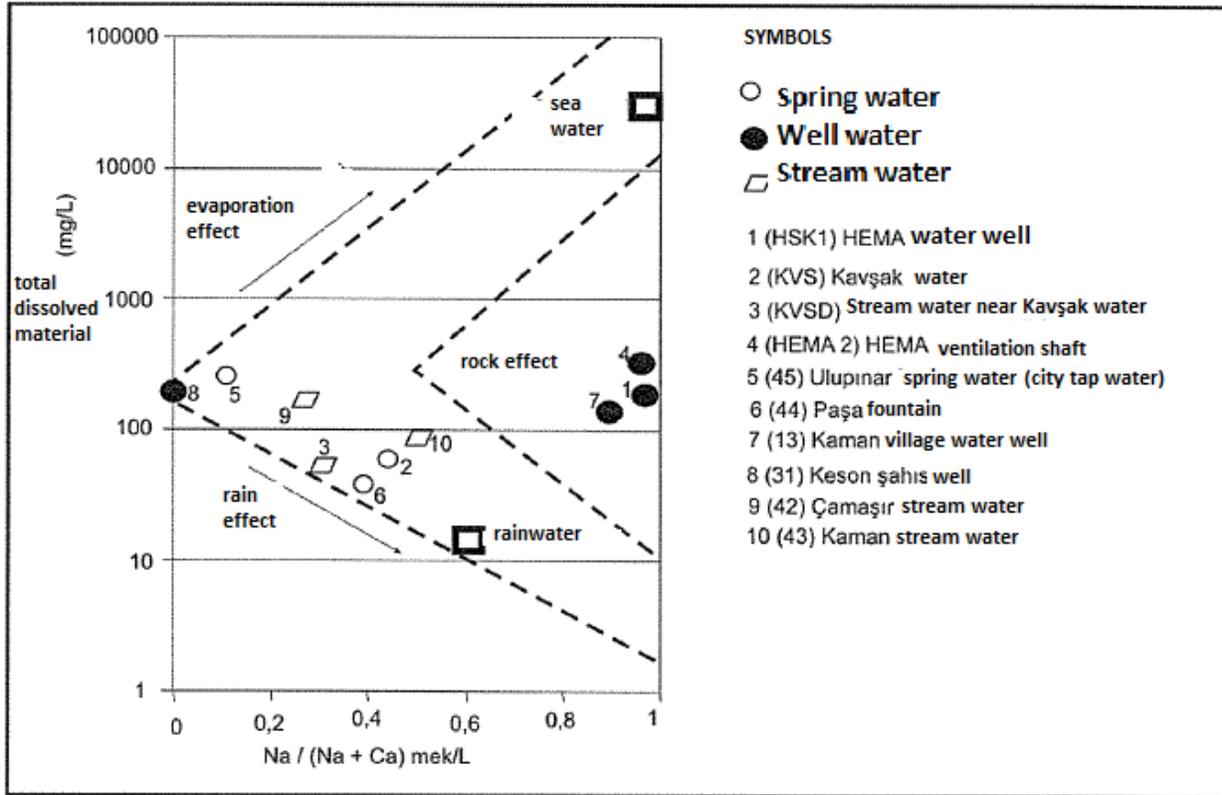
Figure 21: The change of the Na/(Na+Ca) weight ratio as a function of the total dissolved material (Gibbs, 1970)

For the clarification of the chemical properties of water, in order to distinguish the cases in which water-rock interaction has taken place, a diagram proposed by Gibbs (1970) is used. In this diagram, it is shown that HSK1, HEMA2 and no.13 Kaman drinking water well, which gets water from the pressurised cracked andesite aquifer, provide water samples that have chemical properties which have developed due to a long-term interaction with the rock; all other water samples that were analysed (Kavşak water, all stream water, Ulupınar spring water, Paşa fountain, shallow and widescale caisson wells) develop their chemical properties due to the effects of rainwater, and the water's circulation inside the rock is not long enough for reacting with the rock.

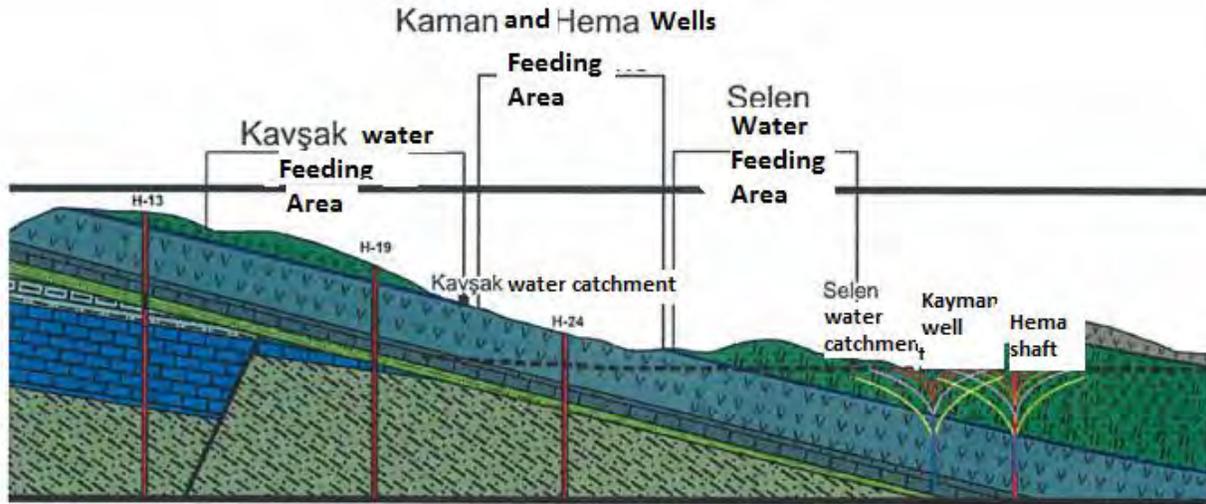
Figure 22: geological-hydrogeological relation and feeding areas between Kavşak water, Selen water, HEMA2, HSK1 and no.13 Kaman Drinking Water Well (for the legend, the scale etc. see Att.1)

The aquifer of Kavşak water is the unit composed of Upper Cretaceous-Campanian-aged Tuff, Sandstone, Siltstone and Limestone (Figure 22). The andesite aquifer at the bottom and the tuff aquifer at the top are separated from each other by the impermeable marl between them. Rainwater inside this unit moves between

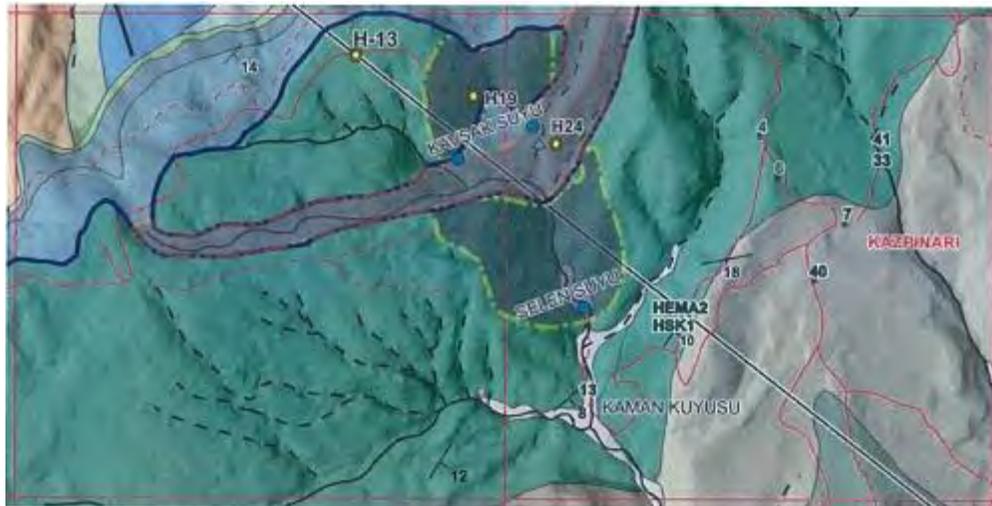
Figure 23: The map indicating Kavşak water, Selen water and no.13 Kaman Drinking Water Well feeding areas (for the legend, the scale etc. see Att.1)
