HEMA AMASRA HARDCOAL PROJECT BARTIN, TURKEY

HEALTH AND SAFETY ASSESSMENT and SOCIAL – LABOR AUDIT FOLLOW-UP

HATTAT Enerji Maden Ticaret A.Ş.
HA1144
DRAFT REPORT
21.03.2015, Rev.01

Task B2a Social-Labour Audit of Chinese Contractor

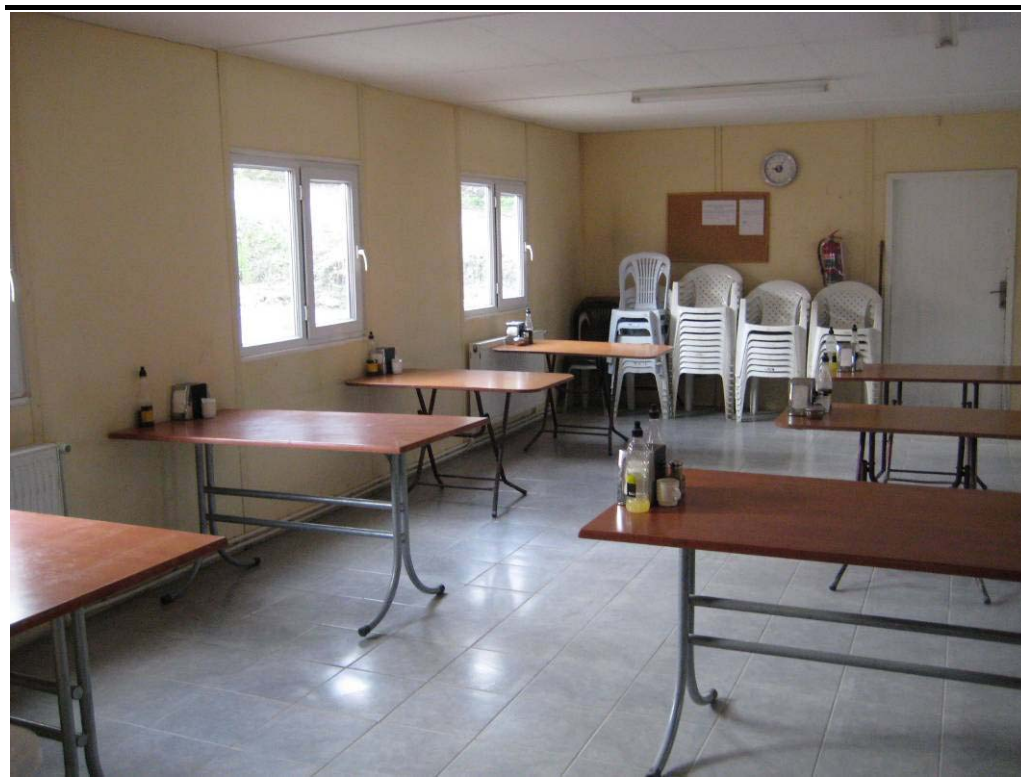
Photo 6 Canteen used by the Chinese workers at Shaft # 1.

Based on the on-site observations by ERM, the accommodation compound for the Chinese workers at Shaft #1 is located approximately 250 m from the shaft and consists of four single storey buildings (photo 1 in *Annex B*), including one dormitory building, a canteen with an adjoining kitchen (photo 6 in *Annex B*), a storage building and a building for working clothes adjacent to the dormitory building. The dormitory building comprises 5 rooms with approximately 24 m² floor area and 62 m³ volume each. In addition, 3 toilets, 2 shower rooms and 1 wash basin are provided within the dormitory building (photos 17-20 in *Annex B*). Each room in the dormitory is shared by 3 to 6 workers and all rooms are fitted with 3 double bunk beds regardless of the number of occupants. The rooms are equipped with 8 metal lockers with volume of approximately 1 m³ each, and each worker/occupant is entitled to up to approximately 2 m³ of locker space (photo 18 in *Annex B*). The rooms are also equipped with a table and a radiator (photo 17-18 in *Annex B*). The doors of the room are lockable and each worker is provided with a key (photo 18 in *Annex B*).

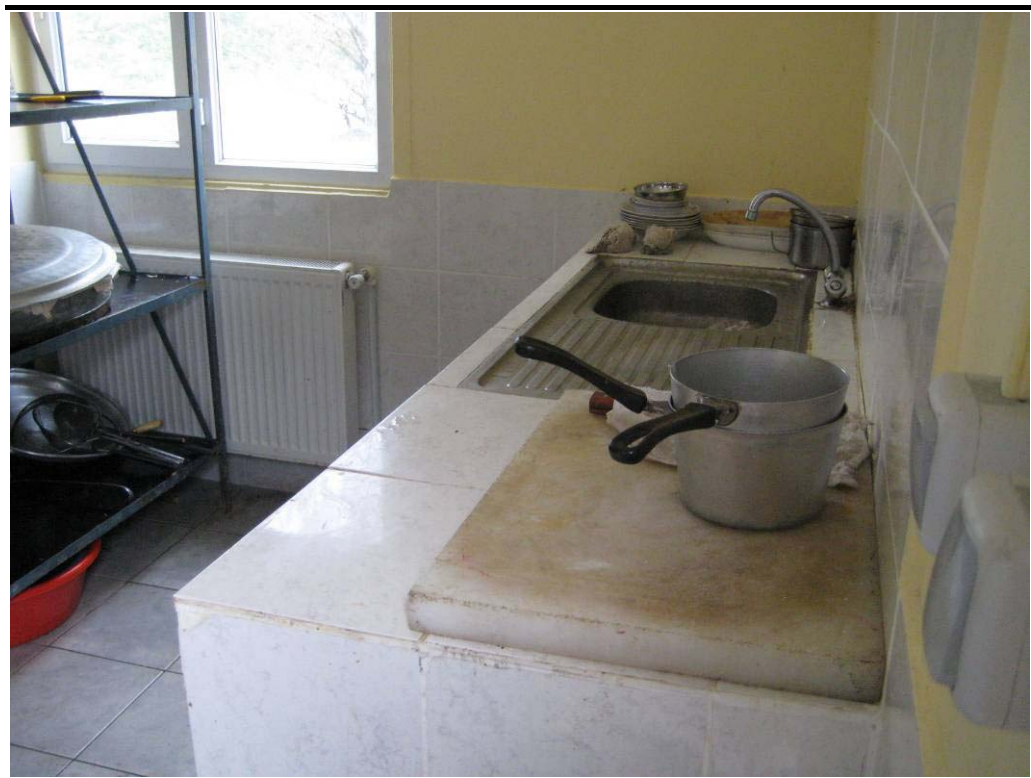
Photo 11 Kitchen used by the Chinese workers at Shaft # 1 with food stored on the floor.
